Apartment Development at Prussia Street

Basement Impact Assessment (BIA)

Report No. B2111-AYE-GEO-R001

Client: Randalswood Construction LTD.

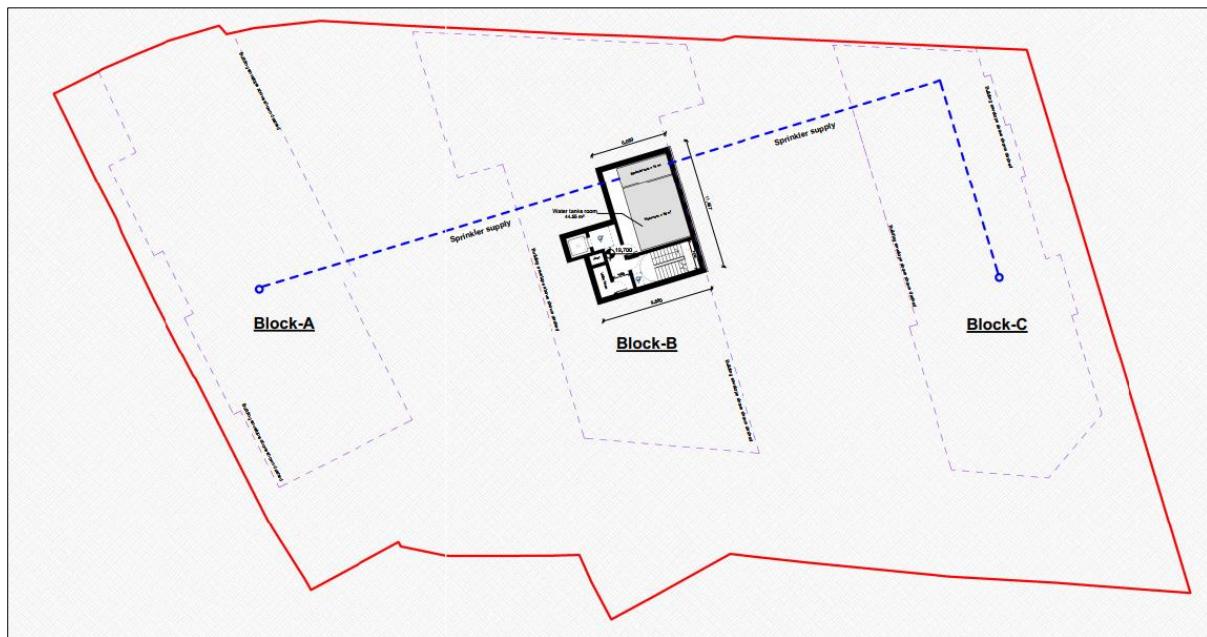
Figure 1.5: Block B Basement Location & Building Envelopes

(ref. Downey - Drawing No. 243-046-PL-100)

The proposed finished floor levels of the apartment blocks and ground levels in the communal open space areas vary from +23.0 / +22.5m OD. Block B basement finished floor level is +19.7m OD.

It is envisaged that this basement area will be formed by battered excavation on the basis of its size relative to the apartment building footprint. Therefore, a larger secant piled wall installation will not be required.

The layout plan of the Block B basement area relative to the proposed building envelope is detailed in Figures 1.5 and 1.6 below.
